# Osage Beach FPD

## Station 1 Study

AUGUST 2021

## Conditions Assessment & Recommendation

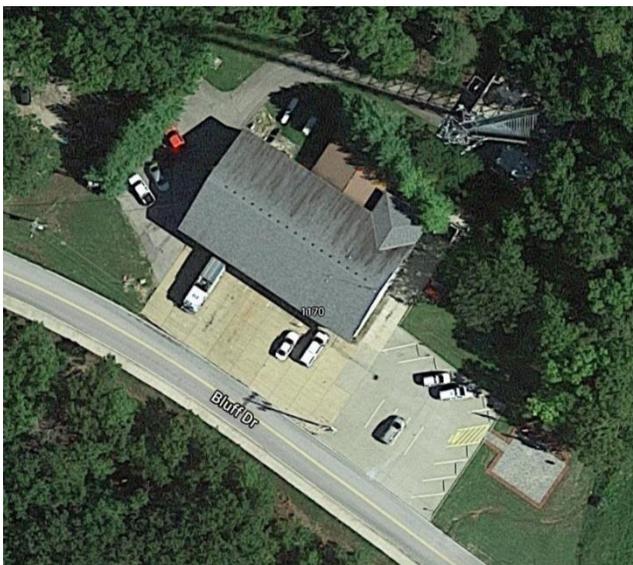
Aerial – Station 1

The station fronts onto Bluff Drive and is oriented in a NW/SE alignment (parallel to Bluff Drive). The station is approximately 110' x 60' with appurtenances for Classroom and Deck to the back of the facility. Also situated on this site is communications tower that is estimated to be in the 100 to 120-foot height range.

Visitor parking is located on the SE area of the site adjacent to a Public Safety Memorial and accommodates approximately 14 visitor parking stalls. Staff parking is generally to the NW of the station and provides approximately 8 parking stalls. Command staff parking is generally located at the front of the station. As the station was originally design with a service pit, an exterior walk-way to the service pit is provided at the 5<sup>th</sup> Bay.

Apparatus bays accommodate back-in parking via a front ramp that is approximately 50' deep. This dept of ramp allows for engine checks and routine maintenance without extending beyond the front property line. The front aprons were recently replaced with reinforced concrete. Trench drains were added to the apron near the building as the site slopes towards the bays.

Overhead electrical service is located across the front of the property with one pole located in the visitor parking lot. As the station is located on a curve, east/south bound traffic has restricted visibility of apparatus departing the station.

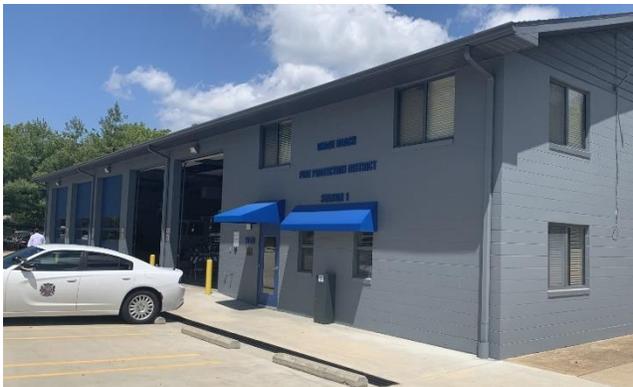
Partial View – Front of Station

The existing Station 1 is a 2-story structure with exterior materials consisting of painted concrete masonry units (CMU), painted wood siding, asphalt shingles with painted wood fascia, soffit and trim. The station was recently painted. The roof is a gable profile with an over build for the rear deck. The classroom addition appears to be gable profile with wood frame structure with prefinished metal panel wall and roof.

Window and door openings are generally metal with windows being aluminum (prefinished) and doors being hollow metal (painted). Overhead garage doors are prefinished, painted metal with 2-rows of glass lites.

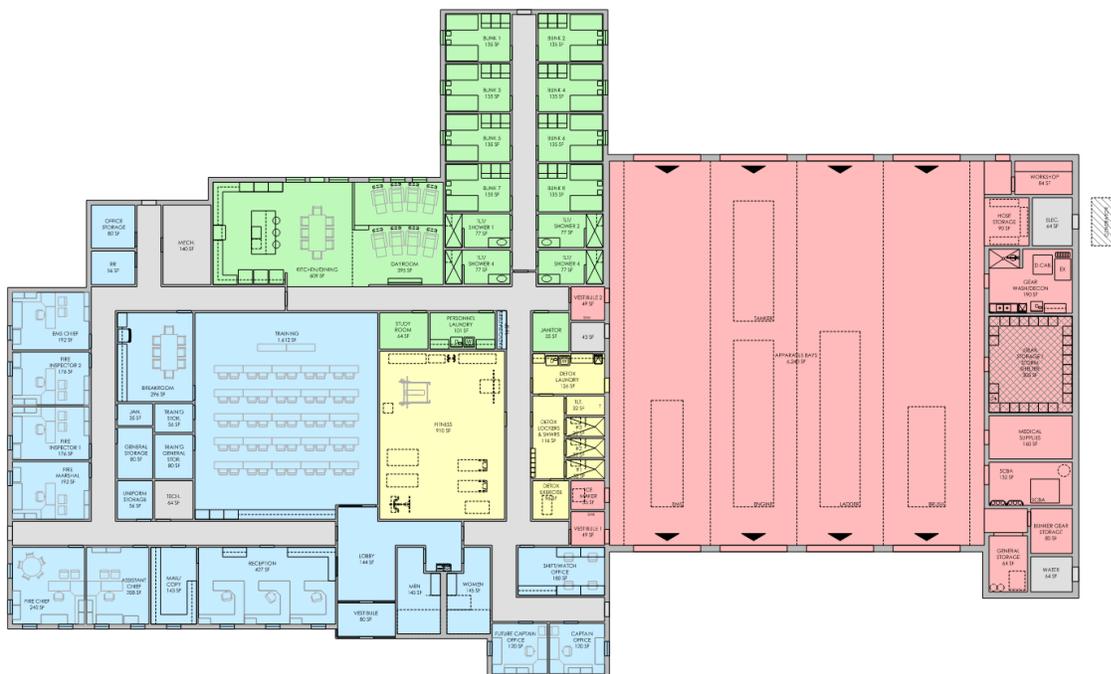
Preliminary Floor Plan

The preliminary floor plan includes all of the spaces listed in the Space Needs spreadsheets. The floor plan provides a recommended layout for all of the listed spaces that are representative of the area required for each space as well as the overall geometry of the plan. While this plan is very representative of the space needs, it is very preliminary and graphically to scale to allow for an understanding of the overall footprint/space requirements.

The floor plan is presented in color for ease of understanding the various areas denoted in the Space Needs. The Lobby, Administration & Support services are represented in blue. The Apparatus Bays are represented in red. The Health & Wellness are represented in yellow and the Living Quarters are represented in green. The grey areas are circulation/corridor as well as common use (mechanical, IT, etc.) uses.

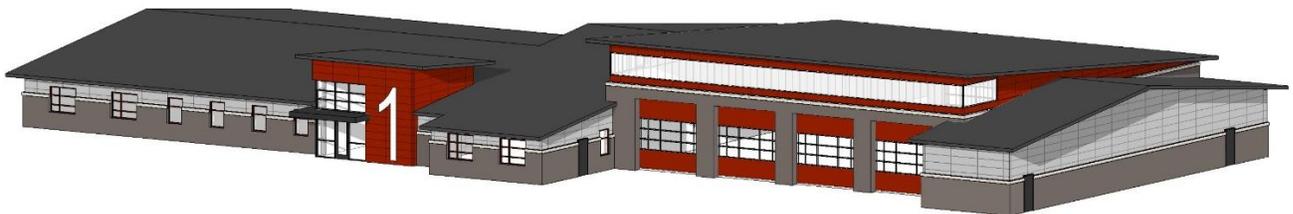
FRONT ELEVATION  
02-10

The preliminary exterior design depicts the front of the station with the apparatus bays in the foreground and the offices/living quarters to the left. The overall design is based on the use of a Pre-Engineered Metal Building (PEMB) structural frame, wall and roof assembly. The envisioned exterior materials are proposed based on long-term performance, prefinished coatings and durability for low maintenance. Prefinished metal panels, masonry at base of building and fiber cement panels for both aesthetics and station accents. All of the materials are combined for a very striking but long-term performance aesthetic. Such materials will have a durability of 40 years and more without a significant investment of maintenance funds.

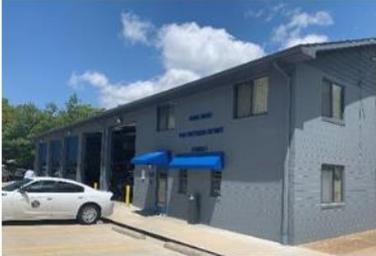
<b>STATION NAME/NO.:</b>	Fire Station #1 (Fire Headquarters)		
<b>STATION ADDRESS/LOCATON:</b>	1170 Bluff Drive, Osage Beach, MO 65065

<p>The station has been in service for 35 years and has undergone several renovation and expansion projects. Current code required life safety provisions are missing. Provisions for fire fighter health and wellness have not kept pace with industry best practices. Provisions for personnel and facility security is lacking to non-existent. Code requirements for this facility type have changed since the original construction making the existing conditions generally non-compliant.</p>			
<b>STRUCTURE</b>			
Date of Construction	1986		
Date(s) of Renovation/Expansion	1998 (classroom), 2007 (upstairs offices), 2012 (deck & kitchen)		
Building Age	35		
Building Area (SF):	~10,300		
Maximum Station Staffing Capability	4 Fire Personnel, 6 Administrative Personnel		
Seismic Protection (if required)	Non-Compliant

Category IV Conformance (if required)	Non-Compliant		
ICC 500 Conformance (if applicable)	Non-Compliant		
Hardened Space / Storm Shelter	<input type="checkbox"/> Yes	<input checked="" type="checkbox"/> No	
Special Considerations	Overall, fair to poor condition		
<b>HEALTH / WELLNESS &amp; SAFETY / SECURITY</b>			
Sprinklers / Smoke Detection	<input type="checkbox"/> N	<input type="checkbox"/> Sprinklers	<input type="checkbox"/> N <input type="checkbox"/> Smoke Detection
<b>BUILDING ASSESSMENT</b>			
Special Considerations	Overall, fair to poor condition		
<b>MEP ASSESSMENT</b>			
Special Considerations	Overall, fair to poor condition		
<b>SITE ASSESSMENT</b>			
Site Risks/Other Observations	Overall, good to fair; no drive-thru bays		
<b>INTERIOR ACCESSIBILITY / ADA</b>			
Special Considerations	Overall, fair condition

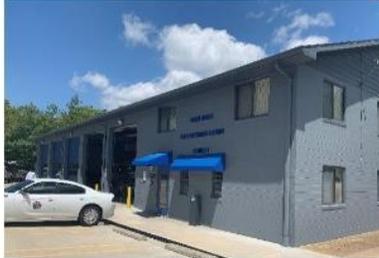
<b>STATION NAME/NO.:</b>	Fire Station #1 (Fire Headquarters)			
<b>STATION ADDRESS/LOCATON:</b>	1170 Bluff Drive, Osage Beach, MO 65065

<p>The station has been in service for 35 years and has undergone several renovation and expansion projects. Life safety provisions are visibly missing. Provisions for fire fighter health and wellness have not kept pace with industry best practices. Provisions for personnel and facility security is lacking to non-existent. Code requirements for this facility type have changed since the original construction making the existing conditions generally non-compliant.</p>				
<b>STRUCTURE</b>				
Date of Construction	1986			
Date(s) of Renovation/Expansion	1998 (classroom), 2007 (upstairs offices), 2012 (deck & kitchen)			
Building Age	35			
Construction Type	IV-B			
Building Construction	CMU Masonry, Wood Trusses, Wood-Stud Walls, Masonry Veneer			
Building Area (SF):	~10,300

Number of Stories:	Two - Living Quarters upstairs/Apparatus Bays-Offices downstairs			
Site Area (SF & Acres):	SF: ~130,000+	Acres: ~3.1+		
Maximum Station Staffing Capability	4 Fire Personnel, 6 Administrative Personnel			
Seismic Protection (if required)	Non-Compliant			
Category IV Conformance (if required)	Non-Compliant			
ICC 500 Conformance (if applicable)	Non-Compliant			
Hardened Space / Storm Shelter	<input type="checkbox"/> Yes	<input checked="" type="checkbox"/> No		
Generator	<input checked="" type="checkbox"/> Yes	<input type="checkbox"/> No		
Auxiliary Power	<input type="checkbox"/> Full Facility	<input checked="" type="checkbox"/> Partial Fac.	<input type="checkbox"/> NG	Fuel Source
General Condition	Fair			
Generator Enclosure (storm rated?)	<input type="checkbox"/> Yes	<input checked="" type="checkbox"/> No	Hurricane Shutters	
Special Considerations	Overall, fair to poor condition

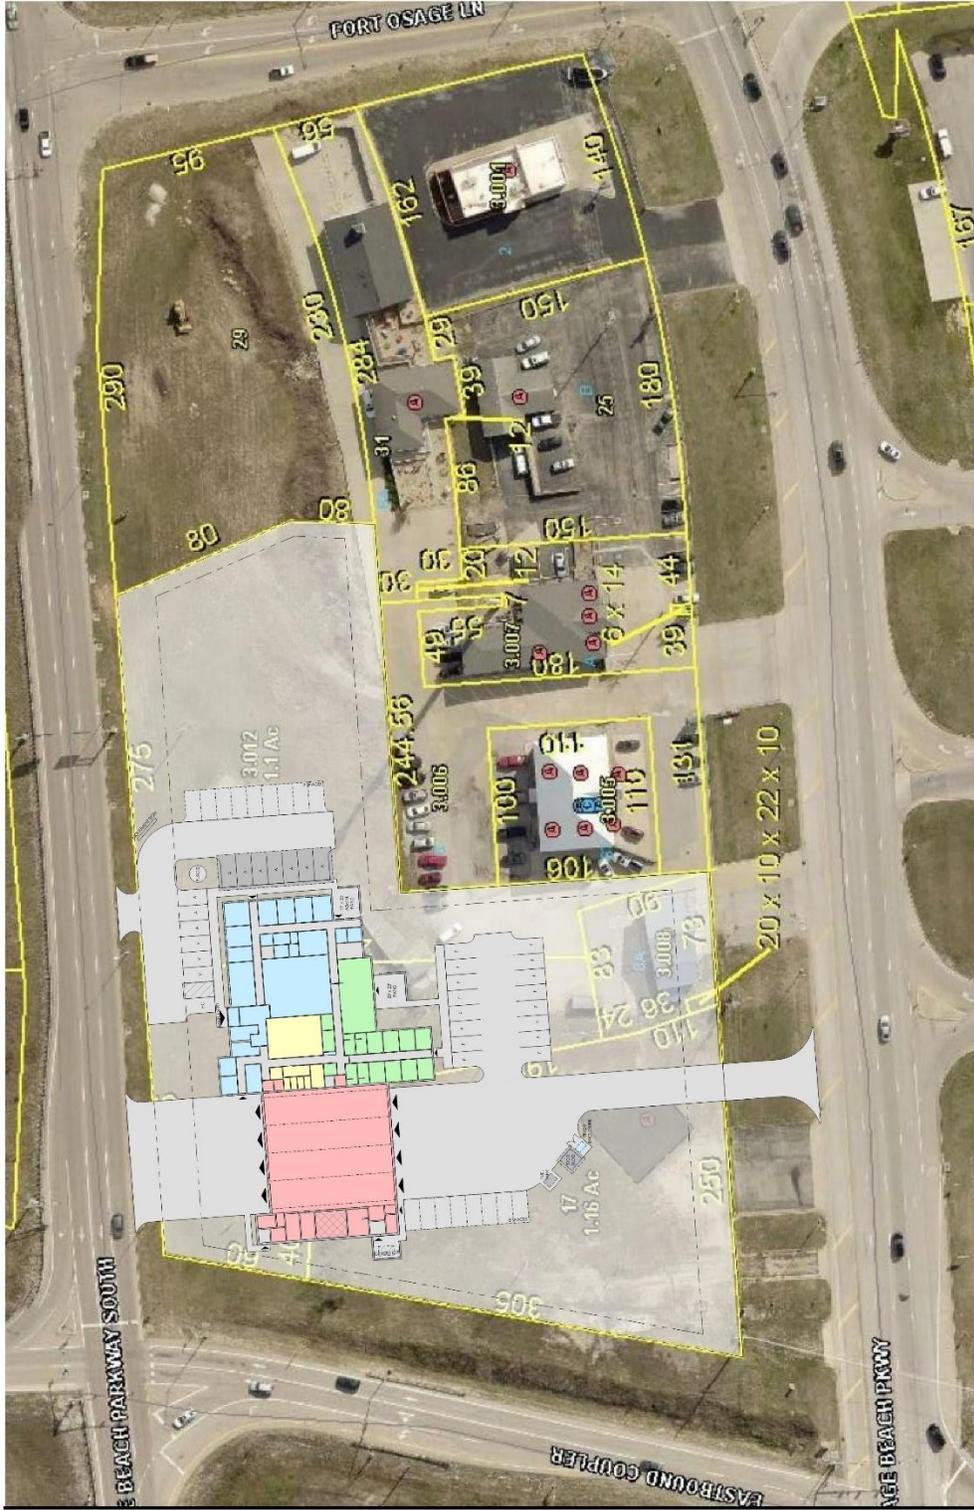
OSAGE BEACH FIRE PROTECTION DISTRICT - SITE PLAN

(Not the actual or final site)
